Erie Highlands Metro District
Erie, CO

Report #: 41496-0
Beginning: January 1, 2022
Expires: December 31, 2022

RESERVE STUDY
"Full"

June 17, 2021

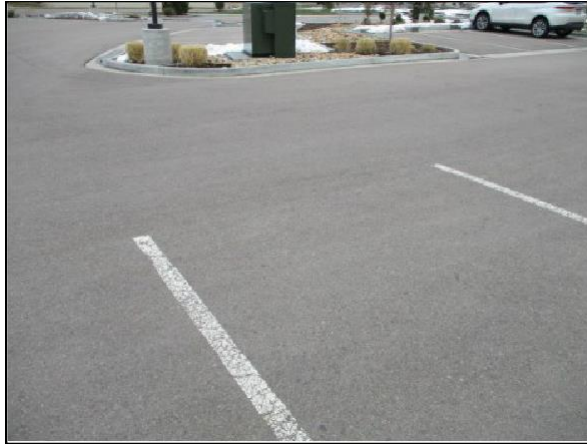
Comments: Asphalt pavement determined to be in good condition typically exhibits a consistent appearance with uniform coloring and relatively smooth texture with only light to moderate signs of wear or age. If present cracking and raveling or other signs of wear are sporadic in nature and asphalt is still up to aesthetic standards for the development. No unusual signs of wear considering the age of the asphalt surface. Useful life below assumes regular seal coating and repairs. The lack of seal coating and repairs can greatly decrease the asphalt's useful life. Resurfacing is typically one of the larger expense items in a reserve study. When need to resurface is apparent within a couple of years consult with geotechnical engineer for recommendations specifications / scope of work and project oversight. As routine maintenance keep surfaces clean and free of debris ensure that drains are free flowing repair cracks and clean oil stains promptly. Assuming proactive maintenance plan to resurface at roughly the time frame below. If regular maintenance and sealing is deferred client may need more extensive repair and replacement projects. Funding below assumes that asphalt has adequate subgrade as well as asphalt fill depth. If fill depth is less than 2" client may need to consider a remove and replacement project which can increase costs by 50% or more. Further resources: Pavement Surface Condition Field Rating Manual for Asphalt Pavement. <http://co-asphalt.com/resources/maintenance-and-preservation/>

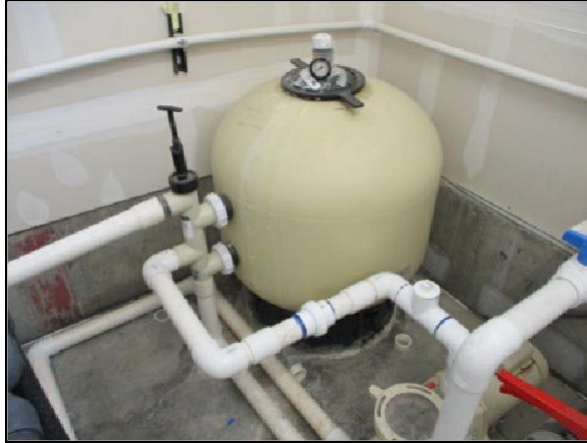
Pool vendor should inspect regularly for optimal performance and address any repairs or preventive maintenance as needed. Life can vary depending on location as well as level of use and preventive maintenance. In most cases replacement cost does not meet threshold for Reserve funding. Replace as needed within annual Operating budget. Vendor should inspect regularly for optimal performance and address any repairs or preventive maintenance as needed. Life can vary depending on location as well as level of use and preventive maintenance. Plan to replace at the approximate interval shown below.

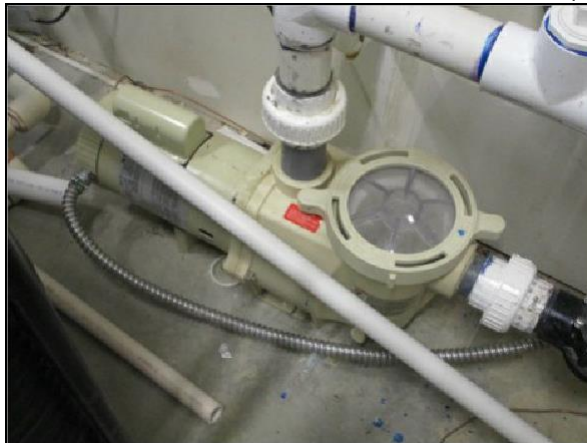
Comments: Pumps should be inspected regularly for leaks and other mechanical problems. Cost shown is based on replacement with the same type and size unless otherwise noted and includes small allowance for new piping/valves/other repairs as needed.
