Erie Highlands Metro District
Erie, CO

Report #: 41496-0
Beginning: January 1, 2022
Expires: December 31, 2022

RESERVE STUDY
"Full"

June 17, 2021

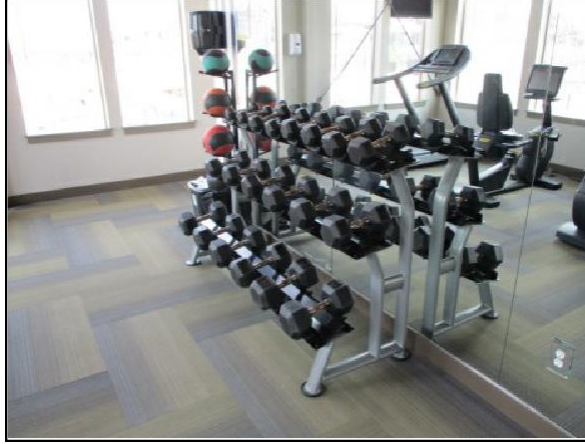
Comments: Room was observed to be in good condition. Flooring was clean and free of issues. Fixtures and equipment appeared to be in good condition. Fitness room should be remodeled at the approximate interval shown here in order to maintain good appearance and functionality. Remodeling typically includes replacement of flooring lighting mirrors (if necessary) and can also incorporate replacement of other furnishings such as televisions. Best practice is to coordinate remodeling with other projects such as remodeling of other amenity areas or with replacement of exercise equipment.

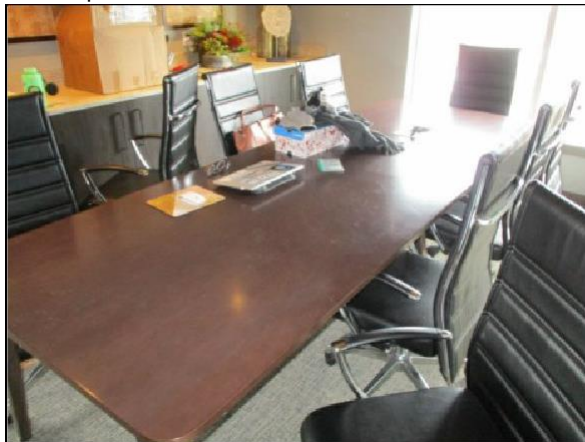
Comments: Includes (1) Table (2) Chairs (1) Cabinet (40 GSY) Carpet (432) Wall paint.. Office was observed to be in good condition. Flooring was clean and free of issues. Fixtures and equipment appeared to be in good condition. Periodic office remodeling is prudent in order to maintain an attractive functional workspace for personnel. Typical projects often include replacement of room finishes and furnishings and may also include replacement of IT equipment phones office supplies storage units etc. Life estimates can vary greatly depending on level of use and preferences of client. If the office is used as a public" area for hosting potential buyers and other important visitors

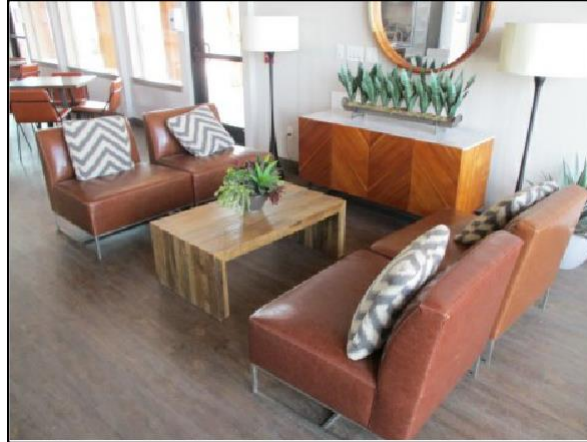
Comp #: 27250 Clubhouse Furniture - Replace

Comments: Includes (8) Lounge chair (3) Side table (6) Table (19) Chairs (1) Sofa (4) Lamps. The furniture and decor appeared in generally good condition. No damage fading or outdated appearances of the furniture was observed. This component recommends funding for periodic replacement/refurbishment of interior furnishings and decor such as furniture artwork window treatments misc. decorative items etc. in order to maintain a desirable aesthetic in the common areas. Cost estimates can vary greatly depending on the amount of items to be replaced at each project and the style and quality of replacement options. Best practice is to coordinate this type of project with other interior projects such as flooring replacement painting etc. Schedule and cost estimates should be re-evaluated during future Reserve Study updates and adjusted as needed based on the client's good judgment.

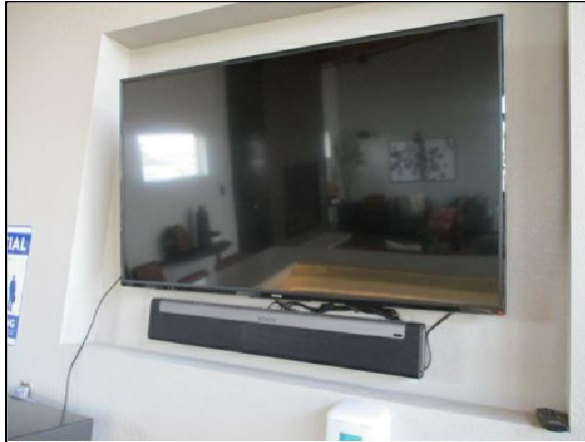
Comp #: 27290 A/V Equipment - Replace**Quantity: ~ (12) Pieces**

Comments: Includes (3) TVs (3) Soundbar (6) Speaker. Minimal or no subjective/aesthetic value for this component. Useful life is based primarily on normal expectations for service/performance life in this location. Unless otherwise noted remaining useful life expectancy is based primarily on original installation or last replacement/purchase date our experience with similar systems/components and assuming normal amount of usage and good preventive maintenance. A/V equipment have a relatively short useful life (depending on the application and level of use) due to advancements in technology. Plan to replace/upgrade the existing equipment at the approximate interval shown here to ensure proper function and uninterrupted service. Keep track of any partial replacements and include cost history during future Reserve Study updates.

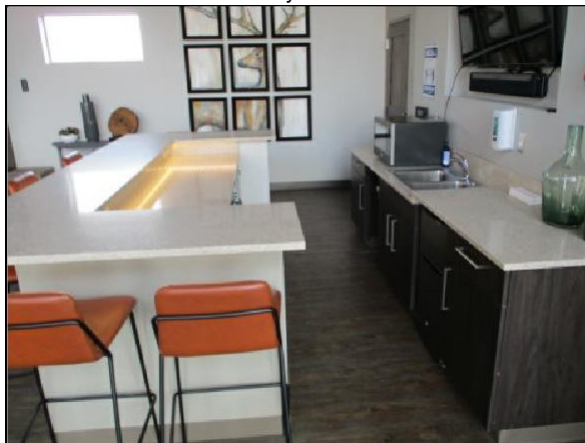
Comments: Includes (52) GSF of Counters (18) LF of Base Cabinets. Kitchen was observed to be in fair condition. Counters and cabinets were clean and mostly free of issues. Fixtures appeared to be in fair condition. Kitchen materials typically have an extended useful life. However many clients choose to refurbish the kitchen periodically for aesthetic updating. This may include refurbishment/refinishing of kitchen cabinets and countertops replacement of sinks installation/replacement of under-cabinet lighting etc. Should ideally be coordinated with replacement of the kitchen appliances. Best practice is to coordinate this project with other amenity areas such as bathrooms or other amenity rooms.

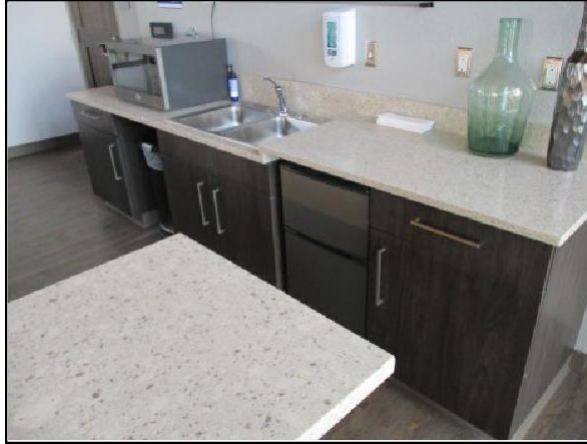
Comp #: 27320 Kitchen Appliances - Replace**Quantity: ~ (3) Appliances**

Comments: Includes (1) Mini fridge (1) Microwave (1) Oven/Range. Individual appliances were not tested during inspection and are assumed to be in functional operating condition unless otherwise noted. Useful life can vary greatly depending on level of use quality care and maintenance etc. Funding recommendation shown here is for replacing with comparable quality commercial-grade appliances.

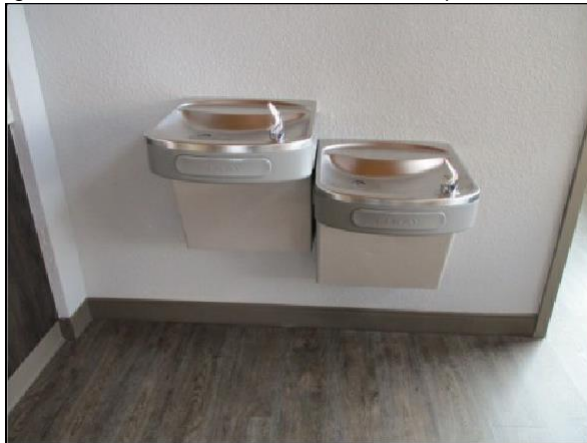
Comp #: 27330 Drinking Fountains - Replace**Quantity: ~ (4) Units**

Comments: No noted or reported issues with the drinking fountains at the time of the inspection however the drinking fountains may need to be upgraded in the future due to aesthetic reasons. Drinking fountains were not tested during site inspection but are assumed to be functional. Should be cleaned and inspected regularly as an Operating expense to ensure safe/sanitary conditions and proper function. Best practice is often to replace at the same time as other exterior furnishings if present such as pool furniture picnic tables etc. Funding recommendation shown here assumes replacement with comparable types.

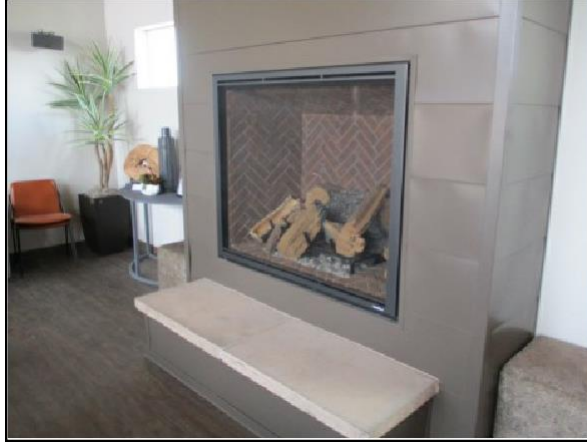
Comp #: 29380 Fireplace - Replace

Comments: Minimal or no subjective/aesthetic value for this component. Useful life is based primarily on normal expectations for service/performance life in this location. Unless otherwise noted remaining useful life expectancy is based primarily on original installation or last replacement/purchase date our experience with similar systems/components and assuming normal amount of usage and good preventive maintenance. Fireplaces should be inspected and evaluated regularly by servicing vendor. In some cases replacement is warranted due to lack of available replacement parts or to upgrade to more efficient technology. Treat routine repairs/maintenance as an Operating expense. Plan for replacement at the typical service life expectancy indicated below. Useful life can often be extended with proactive service and maintenance. Unless otherwise noted funding for system with same size/capacity as the current system.

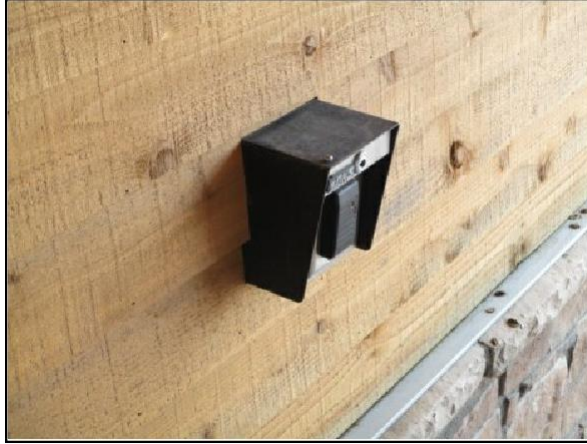
Comp #: 25020 Fob Readers - Replace

Comments: Minimal or no subjective/aesthetic value for this component. Useful life is based primarily on normal expectations for service/performance life in this location. Unless otherwise noted, remaining useful life expectancy is based primarily on original installation or last replacement/purchase date, our experience with similar systems/components, and assuming normal amount of usage and good preventive maintenance. Card/fob reader devices were/were observed to be functional during site inspection. Due to use, exposure, and advancements in technology, plan to replace devices and control system at the approximate interval shown here. Individual readers can often be replaced as an Operating expense due to damage or localized failures. To ensure a functional, compatible system and obtain better pricing, plan on replacing all devices together as one project.

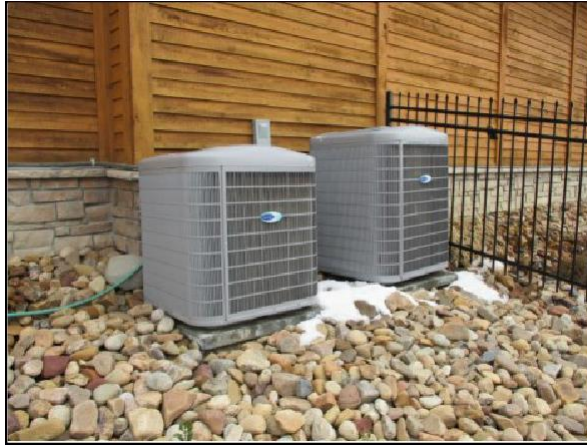
Comp #: 25190 Condenser - Replace

Comments: Minimal or no subjective/aesthetic value for this component. Useful life is based primarily on normal expectations for service/performance life in this location. Unless otherwise noted remaining useful life expectancy is based primarily on original installation or last replacement/purchase date our experience with similar systems/components and assuming normal amount of usage and good preventive maintenance. We recommend that routine repairs and maintenance such as filter replacements system flushing etc. be budgeted as an Operating expense. Useful life can often be extended with proactive service and maintenance. Unless otherwise noted funding for system with same size/capacity as the current system. For split systems we recommend budgeting to replace the entire system (condensing unit and air handler) together in order to obtain better unit pricing and ensure maximum efficiency refrigerant compatibility etc. If additional costs are expected during replacement such as for system reconfiguration or expansion ductwork repairs electrical work etc. costs should be re-evaluated and adjusted as needed during future Reserve Study updates.

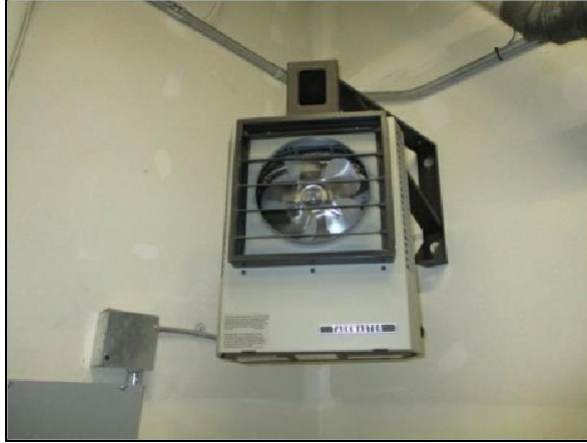
Comp #: 25220 Space Heaters - Replace

Comments: Minimal or no subjective/aesthetic value for this component. Useful life is based primarily on normal expectations for service/performance life in this location. Unless otherwise noted, remaining useful life expectancy is based primarily on original installation or last replacement/purchase date, our experience with similar systems/components, and assuming normal amount of usage and good preventive maintenance. Heaters should be inspected and evaluated regularly by servicing vendor. In some cases, replacement is warranted due to lack of available replacement parts, or to upgrade to more efficient technology. Treat routine repairs/maintenance as an Operating expense. Plan for replacement at the typical service life expectancy indicated below. Useful life can often be extended with proactive service and maintenance. Unless otherwise noted, funding for system with same size/capacity as the current system.

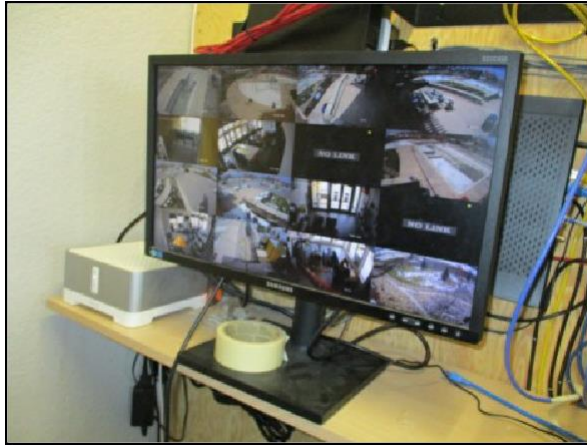
Comp #: 25330 Surveillance System—Upgrade/Replace

Comments: Includes (14) Camera (1) DVR. Minimal or no subjective/aesthetic value for this component. Useful life is based primarily on normal expectations for service/performance life in this location. Unless otherwise noted remaining useful life expectancy is based primarily on original installation or last replacement/purchase date our experience with similar systems/components and assuming normal amount of usage and good preventive maintenance. Security/surveillance systems should be monitored closely to ensure proper function. Whenever possible camera locations should be protected and isolated to prevent tampering and/or theft. Typical modernization projects may include addition and/or replacement of cameras recording equipment monitors software etc. Unless otherwise noted costs assume that existing wiring can be re-used and only the actual cameras and other equipment will be replaced. In many cases replacement or modernization is warranted due to advancement in technology not necessarily due to functional failure of the existing system. Keep track of any partial replacements and include cost history during future Reserve Study updates.
